SCS ENGINEERS, PC

April 3, 2008

Subject: Liner Repair Certification
Geomembrane Liner Penetration – EW-14
Cell 1A, Anson Waste Management Facility

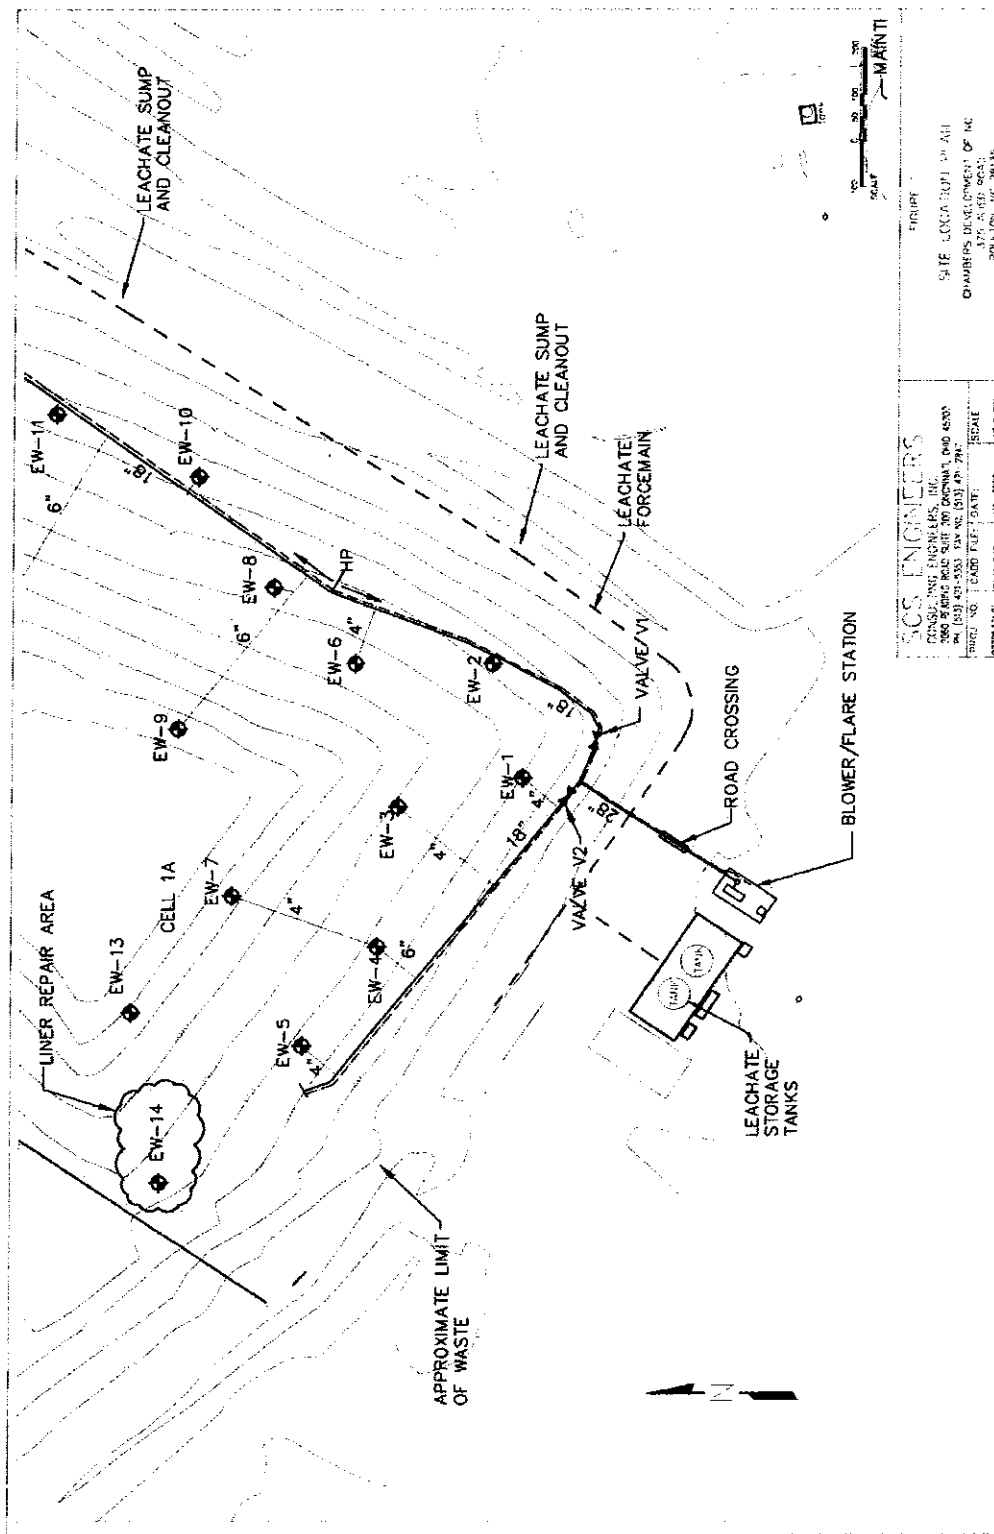
Figure 1. Site Plan Location of Liner Repair Area

On December 12, 2007, the geomembrane liner in Cell 1A was penetrated during the installation of landfill gas extraction well EW-14. Figure 1 shows the approximate location of the penetration at EW-14. Drilling was performed using a 3-ft diameter bucket auger drill rig. It appeared the 2-ft thick soil liner directly underneath the geomembrane liner was not penetrated, or drilled through. Approximately 3 hours after the liner penetration, ten 50-pound bags of granular bentonite were placed in the borehole to provide a seal over the existing soil liner.

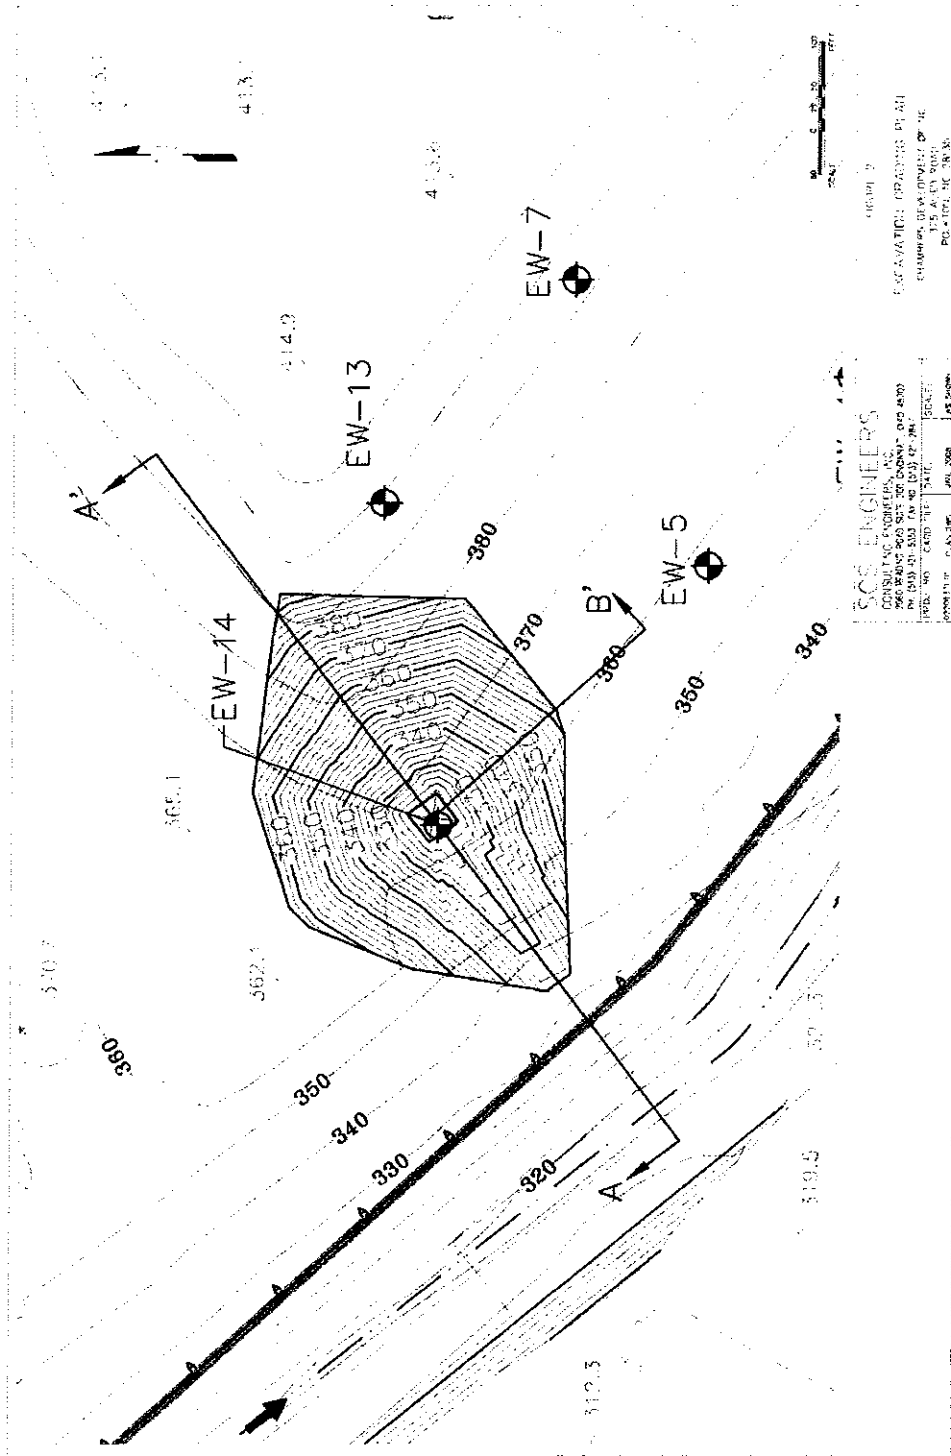
Figure 2. Excavation Grading Plan

In order to avoid damage to the base liner system (due to excavating equipment), waste was excavated to a depth of approximately 323 feet MSL surrounding EW-14, or to the top of the operational layer. The excavated slope was maintained a maximum slope of 2 horizontal to 1 vertical (2H:1V). The excavation also maintained a 20-ft wide ramp for access to the liner repair area. The excavation grading plan (Figure 2) includes a 20-ft by 20-ft "flat" spot centered on the location of the penetration. The operational cover was hand-excavated in this area to expose the geomembrane liner and geocomposite drainage layer. The flat area provided adequate space for the liner crew to access the extent of the liner damage and to repair the penetrated liner.
